Crovie

Conservation Area Appraisal

July 2017

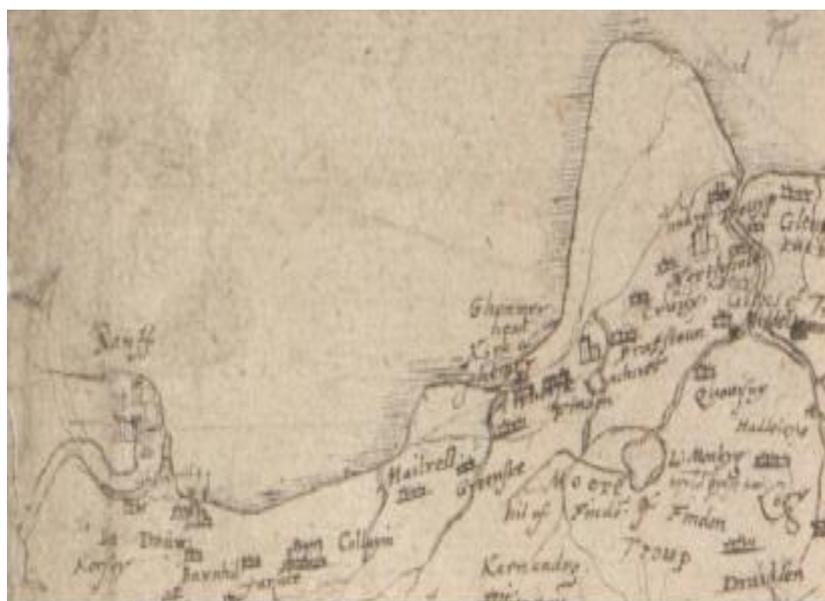
Fig 1 – Timothy Pont; Map of Scotland – Buchan (Pont 10) 1583 – 1614

Timothy Pont’s map of Buchan 1583-1614, indicates an inland settlement called “Cruvy” with “Ghemmy Head” and Kirk identified near the bay. The promontory of “Trowip Head” is also indicated, but there are no other settlements indicated on or near the shore of the bay.

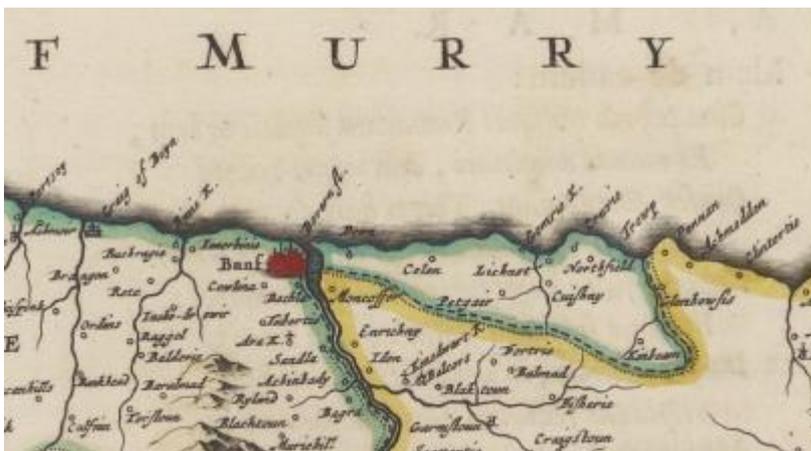
Fig 3 – Joan Blaeu; The Two Shires of Aberdeen & Banff 1654

The Blaeu Atlas of The Two Shires, Aberdeen and Banff, imprinted in 1654, although low on detail the map clearly indicates locations of settlements with simple lozenges. “Cruvie” is indicated on the promontory above the bay.

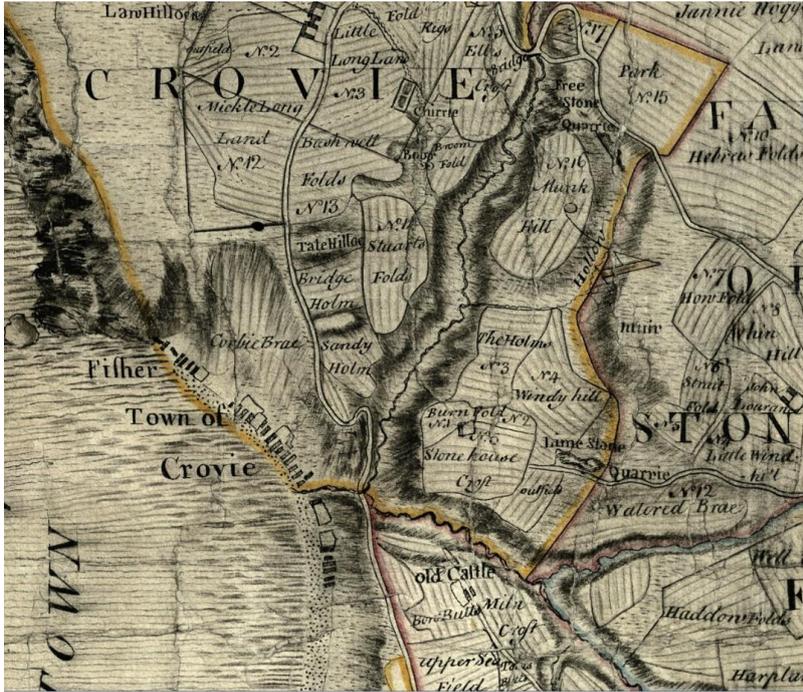
Fig 4 - Estate Map indicating land about Crovie 1767

The Estate Map of 1767 showing lands of Troup and Lightnot (Lichnet) and indicating the boundaries of Crovie, Stonewall, Protstown and Roughward Farms including the northern part of lands in possession of a John Sangster. It also locates the Old Castle to the South East off Miln Croft.

Roads are from North to South, passing through Crovie Farm through the rear of the settlement and North-West from the main road in the East. The southern part of the North to South route may be over-laid by the modern access road today.

The parcels of agricultural land within the boundaries seem to be named with reference to their use, such as Hogs Folds, Goose Pools, Broom Fold and Pease Land. Land is also reserved for the growing of Whin and Broom and also has both free stone and lime stone quarries, indicating that materials for maintaining buildings and their roofs were readily available locally.

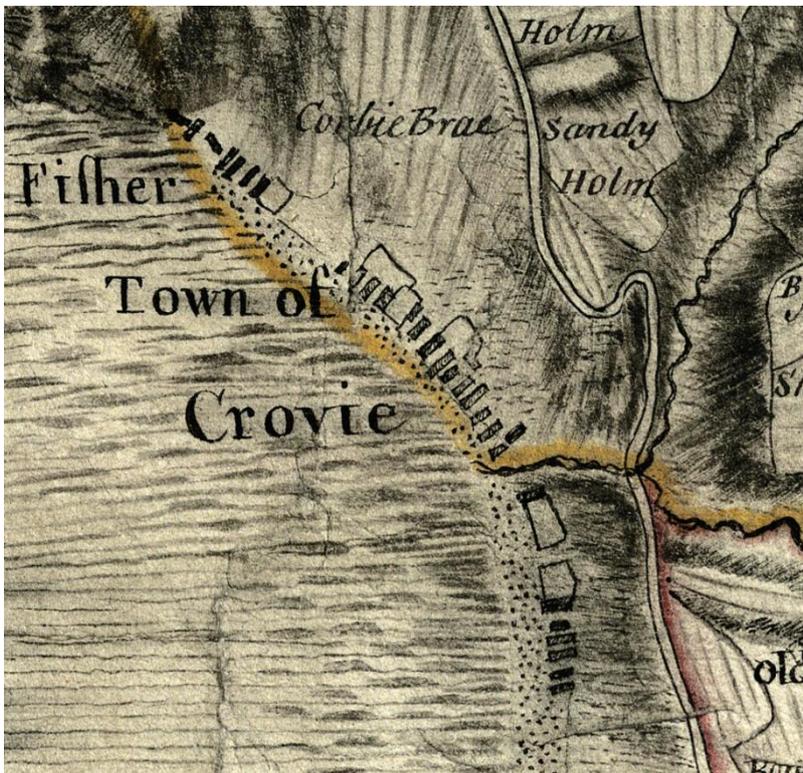
Fig 5 – Estate Map indicating a detailed layout of Fisher Town of Crovie 1767

The Estate Map also provides solid evidence of the layout of the settlement in 1767. An area remains undeveloped in the middle of the north part of the settlement, believed to be due to permanently wet land from the slope behind. Note the northern part of the settlement is within the boundary of Farm of Crovie but the southern part and the road is outwith any boundary. Note also the enclosures or yards about some of the buildings, likely formed by drystone walls.

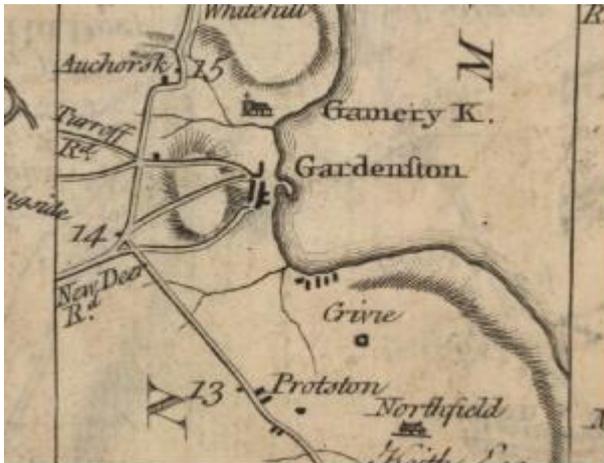
Fig 7 – Extract from Taylor & Skinner Road Map indicating Crovie.

Taylor and Skinner's Road Map of Fraserburgh to Banff, dated 1776, clearly indicates "Crovie" on the shore of the bay with 5 buildings to the north of the burn outlet and an enclosed courtyard building on the promontory above. 3 formal roads rise from Gardenstown to meet the main Banff – Fraserburgh road but Crovie is not served on this map. That there are no formal roads may give credence to sources informing Crovie was only accessible by sea, however the Estate Map indicated at least 2 local routes through Troup Lands to Crovie, eventually joining the main road.

With reference to Historic Environment Scotland records, of those buildings to receive designated listing in 1972, there are six dwellings from the 18th Century which stand on their original footings, although most are repaired and partially rebuilt. The location of these dwellings are mostly to the south of the burn outlet and do not correlate with the Taylor & Skinners map which is therefore believed to be indicative only.

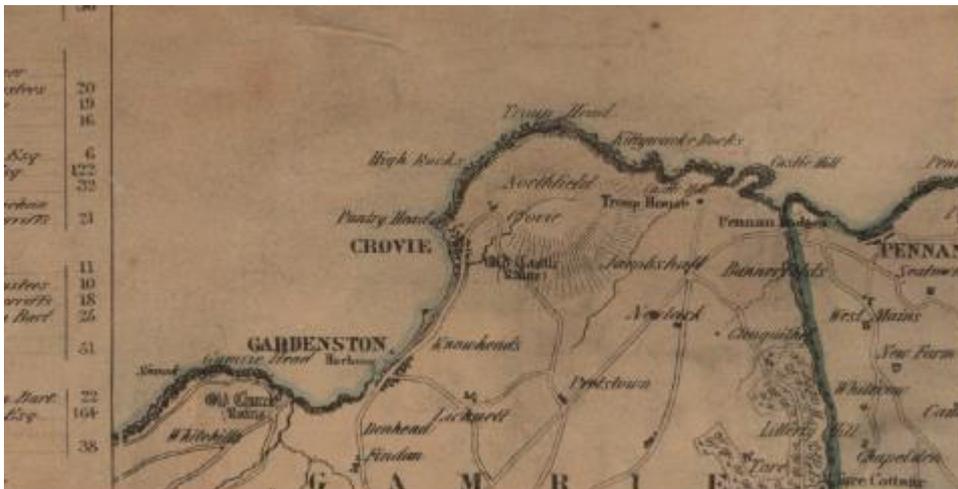
Fig 10 – Alexander Gibb; Map of the North Eastern Districts of Aberdeenshire (1 of 2)

Alexander Gibb’s map of 1858, indicates the track traversing over the creek and forming one continuous route through Crovie to Gardenstown from Troup Head. In addition the map indicates buildings between the base of the hill or cliff and the road through it. However the layouts of other settlements are indicated in a similar fashion, this may simply be the cartographer’s indication of a settlement and is misleading when considering its layout.

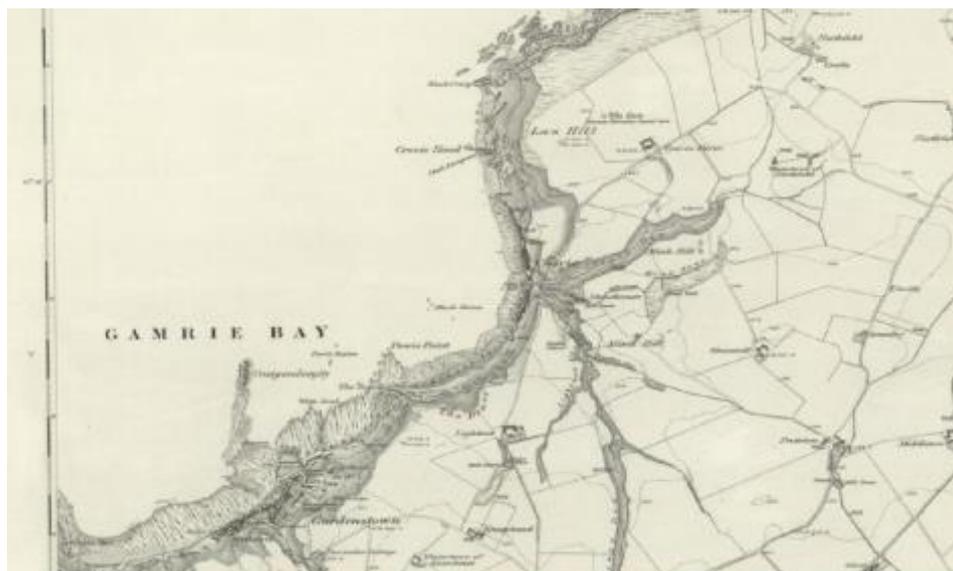
Fig 11 – 1st Edition OS Survey 1869-71

The 1st edition OS map of 1869-71, indicates Crovie Farm as the enclosed court building above Crovie and the detailed layout of the settlement (contrary to the information on Gibb’s) which remains largely unaltered. Also indicated are the East Bridge over the creek and the Hall building. There is still no clear indication of the pier on OS maps until the 1902 revision.

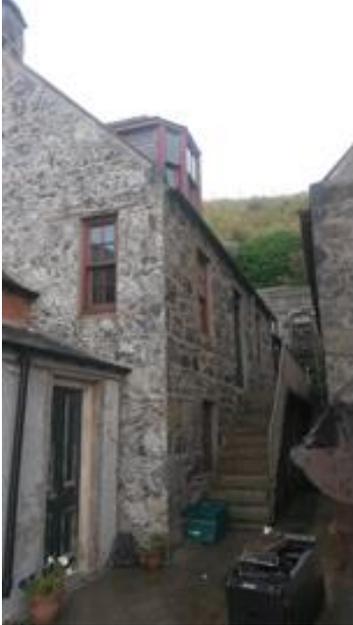
Fig 13 – 2 Storey, Former Access to 1st Floor

- i) Two storey buildings with separate ground and first floor houses, external stone stairs leading to the 1st floor, often with the low range of a separate dwelling house at the gable facing the shore.
 - ii) Two storey buildings built into the slope where the ground floor is half that of the upper floor, often the low range of the separate dwelling at the gable incorporates the ground floor of the principle house.
-

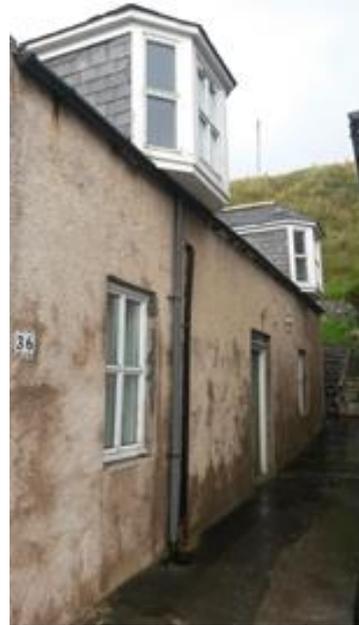
Fig 14 – 1½ Storey (heightened)

- iii) Two storey pair of mirrored houses with ground floor access.
- iv) Typical later Victorian 1½ storey cottages with sash and casement windows and roofs clad in Scotch slate.

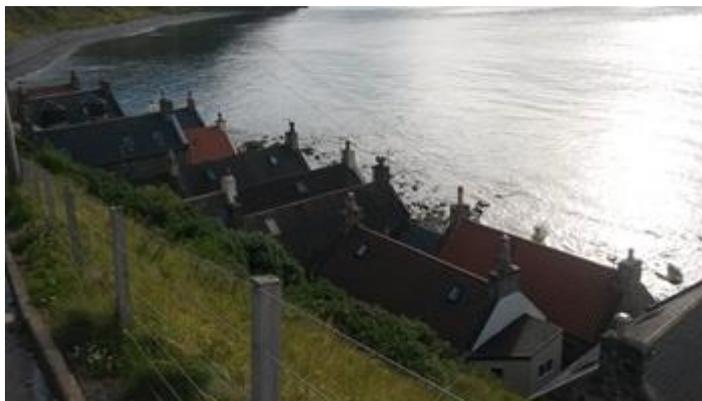
Fig 15 – Image of Roofs with Various Finishes

The roofs of the traditional cottages are now largely clad in either machined, single sized Welsh slate or modern reproduction clay pantile, many with modern detailing and modern Velux type windows. The rest retain their cement profiled roofs from the need for swift repair after storm damage, whilst a few are clad with modern cement tiles and once temporary mineral felt. There are however remains of natural clay pantile to some roofs. Some of the pantile roofs have slate easings, usually 3 courses, laid at their wall heads. This detail may not be typical of Crovie but is a recognised detail from an earlier type of roof finish and is thought to offer greater protection to the wall heads. There is photographic evidence of this detail in historic images.

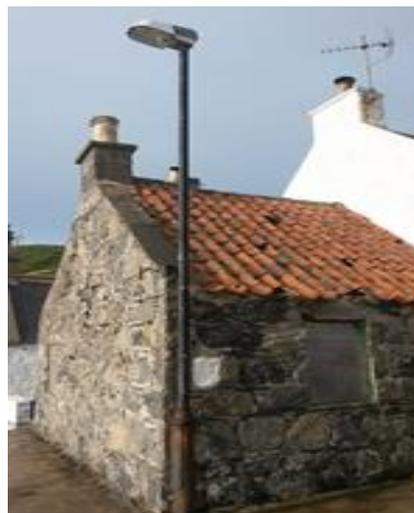
Fig 16 – Natural Clay Pantile

Trade would offer access to materials including clay pantiles which appeared in eastern coastal settlements of both England and Scotland. These tiles would replace early vernacular roof coverings, mortared into place to prevent water ingress in these exposed locations, lending to its character.

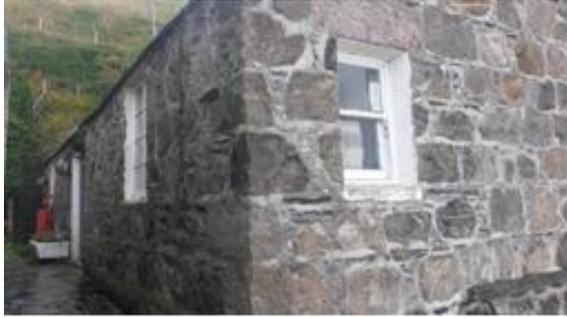
Fig 17 – Little Altered, Un-heightened Example

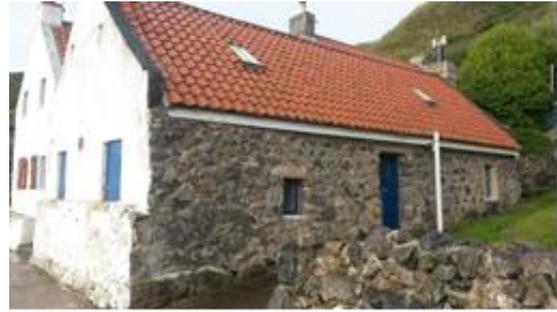
Fig 18 – Rebuilt on earlier footings

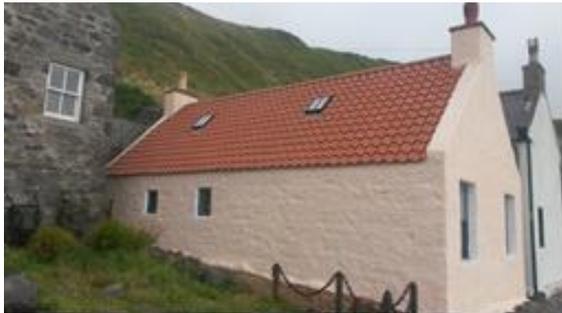
Fig 19 – Altered but Well Presented

Some that have undergone substantial modern intervention are otherwise well maintained and presented in a manner sympathetic to its neighbouring buildings and the conservation area.

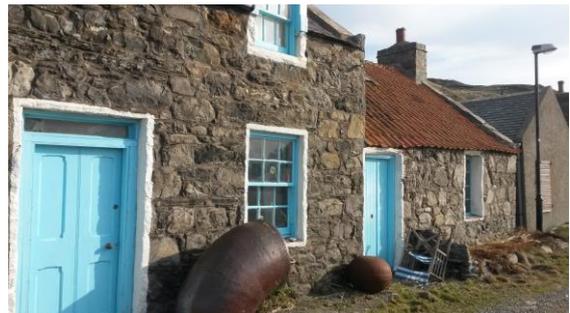
Fig 20 – Traditional Door and Window Assembly

The earliest of traditional doors would have been constructed of ledged and braced timber boarding, possibly beaded boards later. More formal Victorian houses from mid-19th Century are fitted with panelled door assemblies of the period, often with rectangular fanlights above, their decorative detail becoming richer with additional deep mouldings and dentils. Some later change brought in increasing elements of glazing to the door in some cases leading to the need for protection with additional storm doors fitted externally.

Typically, most of the window openings of the earliest houses were enlarged to accommodate the new style sash windows. However these openings were generally smaller than the standards used in the new houses, resulting in half-sized bottom sashes being fitted, lending a new character to the older dwellings. Much of these windows have now been replaced rather than repaired resulting in their meeting rails now being central to the window.

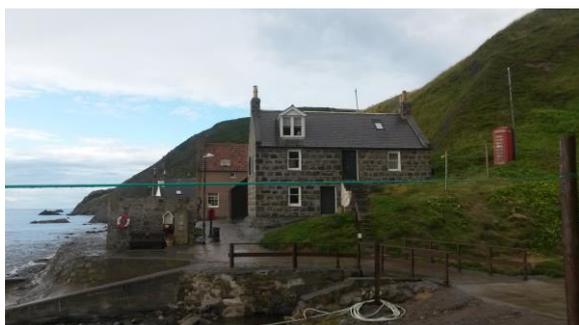
Fig 21 – The Greenie Area by the Pier

The area in the middle of the settlement has been called The Greenie by generations of Crovie's residents. It accommodates the burn from the slopes above and serves as a flood plain when at high tide and therefore remains undeveloped. The ground level of this area has been built up at some point with a stone lined channel to create a contained route for the burn outfall to the shore. A short flight of steps by the footbridge, recast over what is thought to be 18th Century steps, offers an indication of the change in level. It has also served as an area where boats were stored, timber sleepers often placed over the burn to increase storage area.

Given the use of this area and the tragic events prompting the building of the pier, there may be an opportunity for interpretation with an improved designed landscape with seating to enhance the wider conservation area.

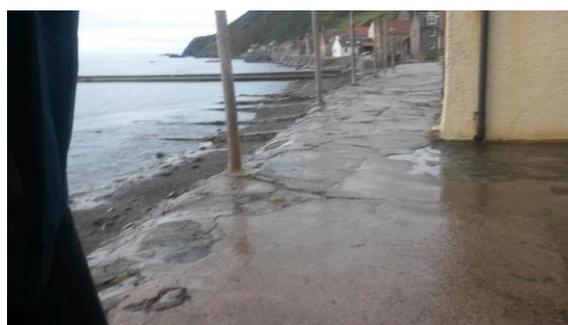
Fig 22 – Bankhead: Posts, Stone and Concrete

The current timber posts and their drying lines along the Bankhead, which replace previous corroded mild-steel poles, is a return to that indicated in historic images and are a reminder of the past activity of a once flourishing fishing community, huddled close together for shelter against the elements, in what dwellings that could be made in the most meagre of spaces from locally available materials.

Once a dirt path, beach stone was laid as part of later improvement works however many were lifted in storm conditions, resulting in them being reset in a layer of concrete, which was extended back to the properties. The last few houses in the north of the settlement are served by a simple gravel path.

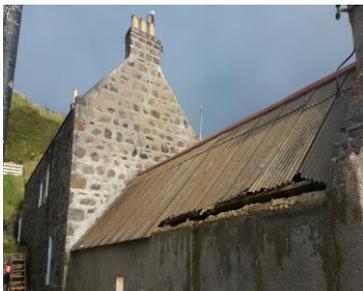
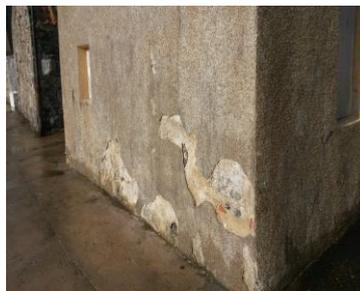
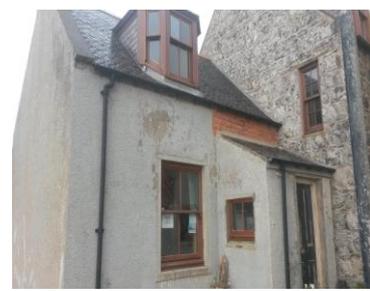
The main concern is the dilapidation of some non-residential structures tied to the principle dwelling houses. Broken roof cladding, unseated roof finishes, thin and faded painter work is to the detriment of the conservation area and is in need of attention.

The condition of degrading asbestos-entrained cement cladding is also a concern and may be a public health issue, especially where it is of a poor, friable or defective condition allowing ready release of asbestos fibres. It is proposed that the Aberdeenshire Council liaise with owners of buildings clad with profiled cement sheet to discuss the need for condition surveys and the potential impact of necessary repairs.

Fixings of various shutter types at window openings in cottage gables show signs of corrosion which stains wall finishes, excessively in some cases, contributing to the deterioration of the visual amenity of the conservation area. In discussion with the local resident and contractor, the saline environment will aggressively attack most metals

An opportunity exists to review and agree a standard design for these shutters with associated non-ferrous fixings.

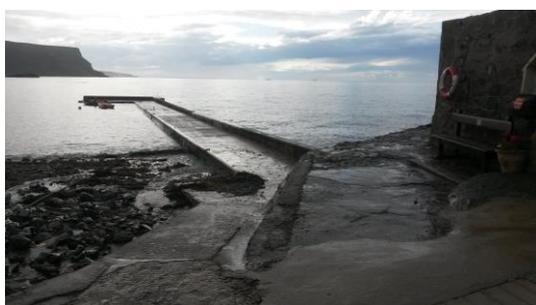
Fig 26 – Pier

The L-plan pier is listed within the designated group listing together with the Bankhead in 1972. Built of rubble with some concrete dressings the listing remains as it was originally at Category B. The Crown Estate completed necessary repair and improvement works in 2013 following agreement with Aberdeenshire Council.

Notwithstanding the major engineering works undertaken to the pier in 2013, its continued inspection, monitoring and proactive repair ensures its operative condition in demanding conditions and maintains its positive contribution to the wider conservation area.

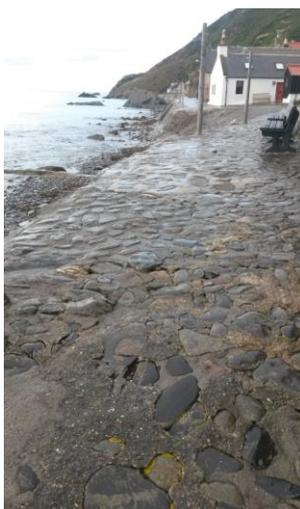
Fig 27 – Beach Stone & Concrete Hardstanding

Like the pier above, the continued inspection, monitoring and proactive repair of hardstanding's, the reinforced raised shoreline of the Bank Head and the retaining walls at the rear of the settlement, ensures their safe condition and their continued contribution to the wider conservation area.

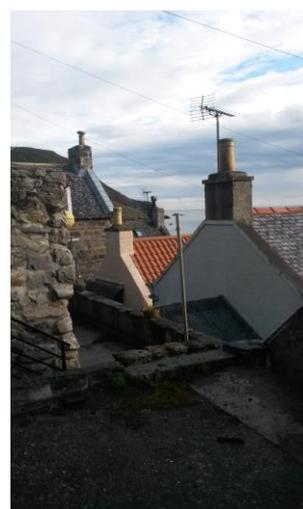
Fig 28 – Retaining Walls

Where retaining walls support the slopes behind properties, routine inspection by homeowners will establish the condition of the walls and their need for repair.
