Pennan

Conservation Area Appraisal

June 2022

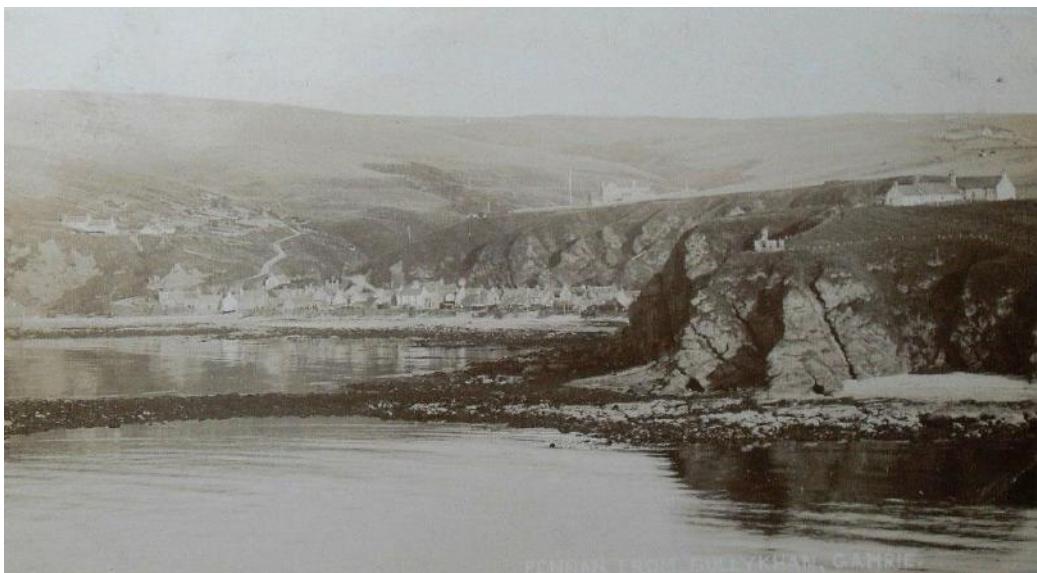
Fig 7 – Early Photograph from the West of Pennan Bay, circa 1903.

Figures 7 and 8 illustrates the two principal routes into and out of Pennan: the eastern road up Black Hill towards the Pennan Farm and New Aberdour, and the south road snaking up the steep slopes above, joining with the main road from Fraserburgh to Banff.

It shows the sloping sandy shore leading up to the sea defences, which were built and maintained by the villagers. These consisted of driven timber posts and heavy-duty timber boards or railway sleepers. Piles of large boulders on the foreshore also served to dissipate the energy of the sea. What is thought to have been the Coast Guard watch house, is on the higher ground of Cullykhan Fort in the foreground. The flagstaff, depicted on the OS Map of 1874, can be seen on top of the hill above Pennan and is likely to have been for Coast Guard use. The large house further up the slope is thought to have been built at the time the image is taken as it is not indicated on OS Maps of 1874 or 1901. It is now 2 houses, Clifftop and Hillcrest. The terraced cottages at the bend, set out in 1837, are hidden behind the slope.

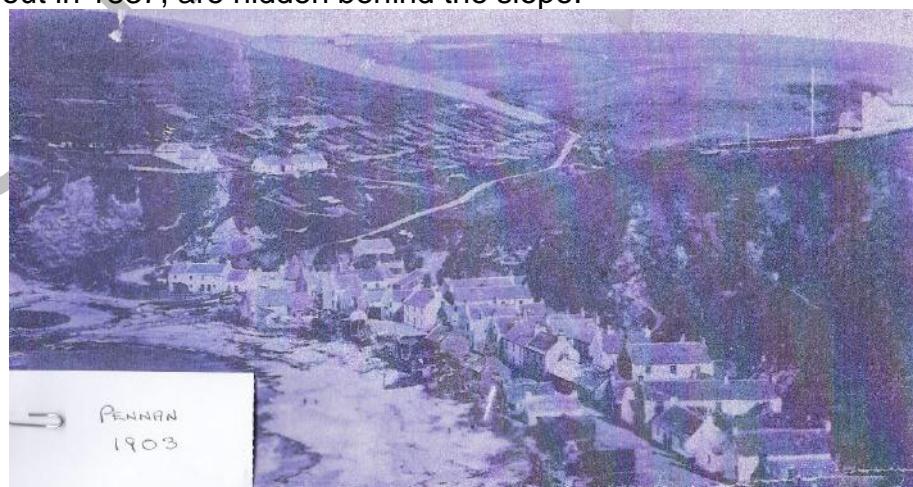
Figure 8 – Early Photograph of Pennan from the West, circa 1903.

Figure 8 provides detail, in conjunction with Ordnance Survey 1st Edition map of 1874, to identify masonry buildings amongst the timber sheds along the top of the shore as well as buildings which once stood but are now lost. The building to the rear of No 48, towards the bottom right-hand corner, is derelict at this time and likely damaged following a land slip. In terms of layout the settlement has seen little change. The image records what may have been a programme of improvement where many of the buildings are painted white, this may be lime wash, perhaps on a rendered finish.

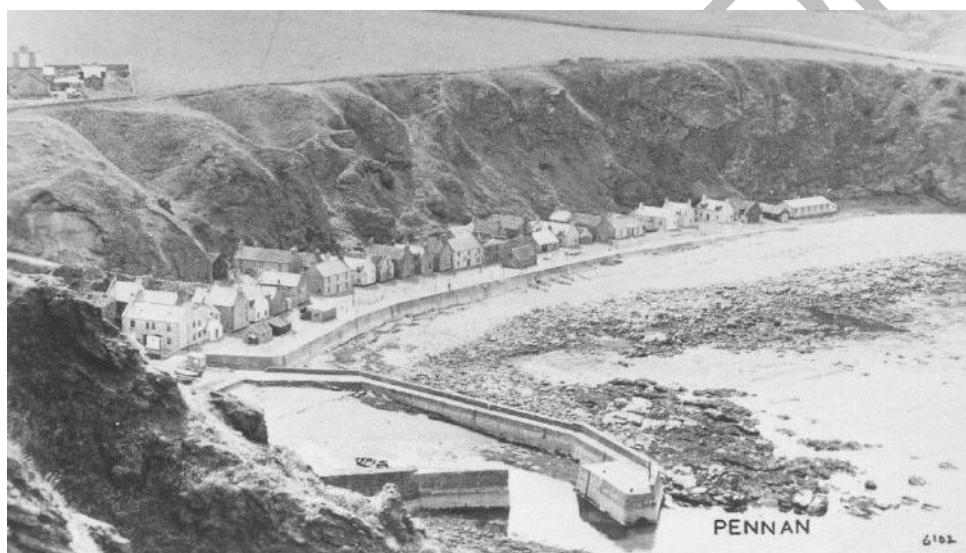
Figure 10 – Photograph of Pennan from the East, circa 1956.

Figure 10 shows the Community Hall at the far west of the settlement, which is still in use today. This structure was formerly an accommodation hut at the aerodrome of Lenabo near Longside during the Great War. It was rebuilt here on a red sandstone base along its perimeter, with later modern extensions to each end.

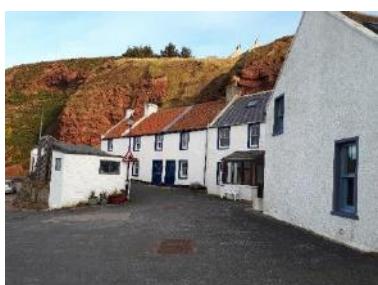
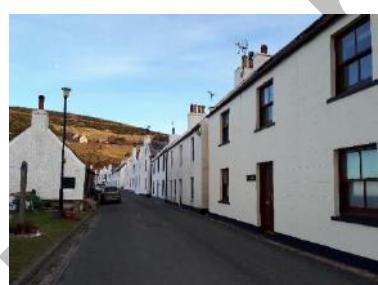
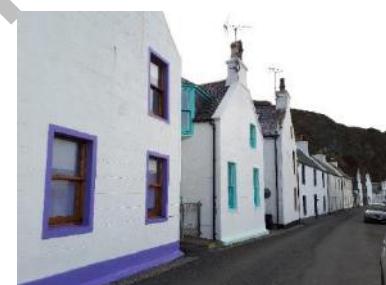
There are two distinct styles of buildings found along the shoreline, those which face the shoreline, and those which have their gable positioned to the shore. These share a number of similarities such as their strong cohesive traditional scales and simple plan forms. They are predominately gabled with chimney stacks, white rendered sandstone walls, with single window and door openings.

Dwellings which are positioned with their gables to the sea, are characteristic of settlements in close proximity to the sea in Aberdeenshire. Traditionally, there would have been no windows positioned on these gables to save them from being damaged in storms, but these have been added in recent years to allow for a pleasant view. These properties have been heightened with the upper floors being converted into living space with the addition of dormer windows.

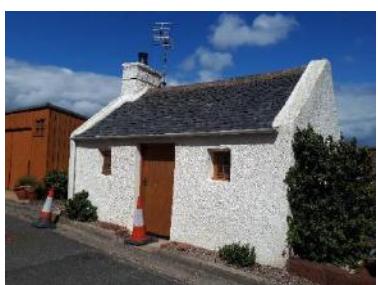
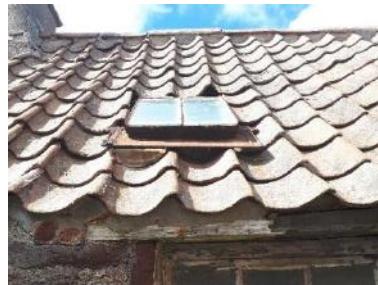
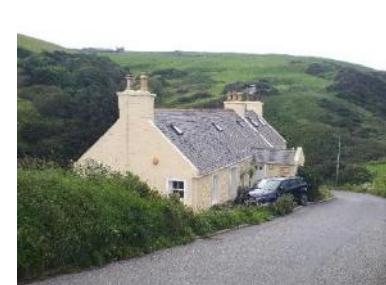
Clay pantiles would have been the traditional roofing material found in Pennan, and some originals can still be seen on some smaller ancillary buildings. Replacements have been carried out using concrete pantiles on properties, where reclaimed clay pantiles would have been preferred. Welsh slate has been used on the majority of properties within the settlement as an alternative roofing material, which is acceptable as a traditional roofing material found in Aberdeenshire, however, clay

pantile is still preferred in this setting. Clay chimney pots can be seen on many properties.

The properties in Pennan have been constructed using locally quarried red sandstone, which due to the harsh weather conditions these buildings face, many have been given a cement render which has been painted white. A small number of properties with exposed sandstone are noted, predominantly those which are not directly facing the shore. A cement-based render can have a detrimental effect on the soft sandstone below by trapping moisture internally and degrading the stone. A lime based harl is preferable to allow for any excess moisture to be expelled from the structure.

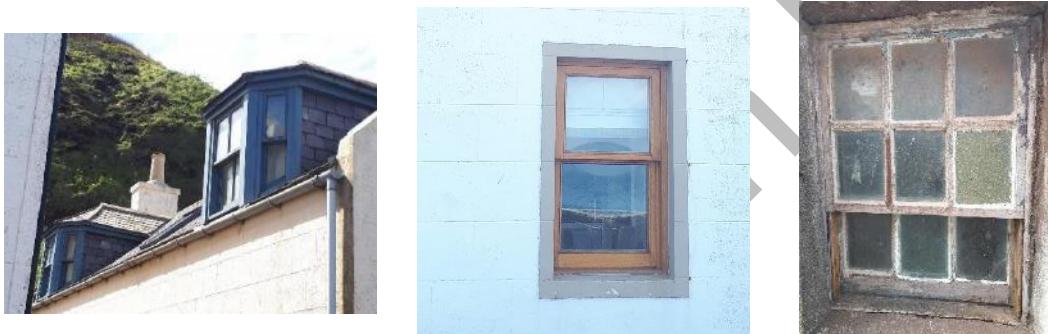
Within Pennan, timber sash and case windows vary considerably in size and design, as well as the design and construction of dormers. There is no one standard design which has been followed throughout the settlement. uPVC windows are seen in some properties in the settlement, as well as oversized box dormers, both of which are not in keeping with the settlement.

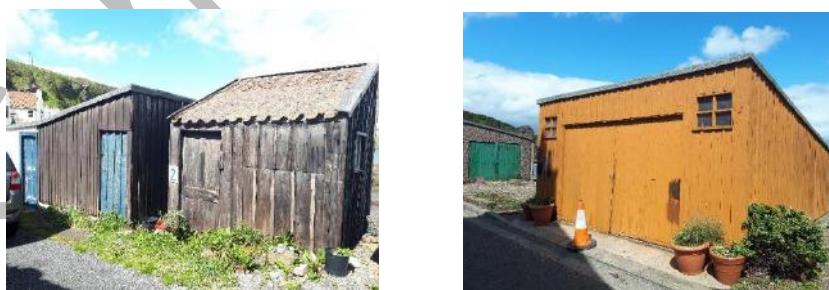
Few sheds/non-domestic buildings are in existence in Pennan, as a large number were lost from the shore during the storm in 1953. There are however a small number of original buildings which remain. Some of these are original, and have been little altered, which provide evidence of the material choices and design which are appropriate in this setting. The materials and shape have been used in new designs within the settlement.

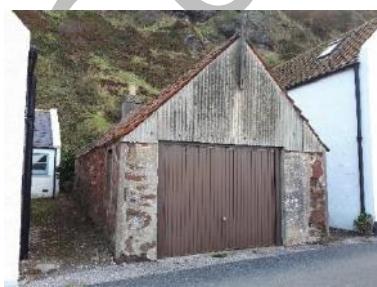
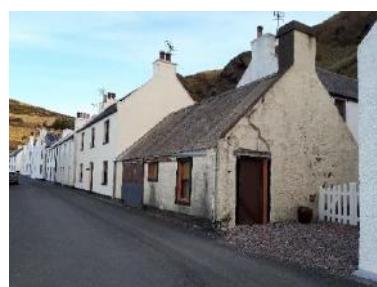
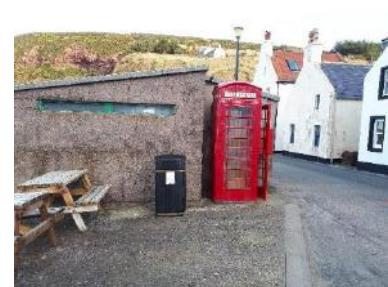
There are a number of ancillary buildings i.e. sheds/garages which have seen less attention given to their maintenance in recent years. On these buildings, missing or damaged rainwater goods are noted and a lack of upkeep in the general appearance of these buildings. Inappropriate materials have also been used on these buildings, such as asbestos, cement harl and uPVC rainwater goods.

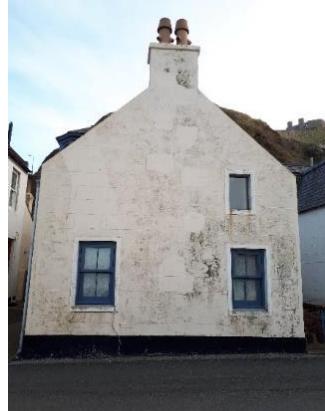
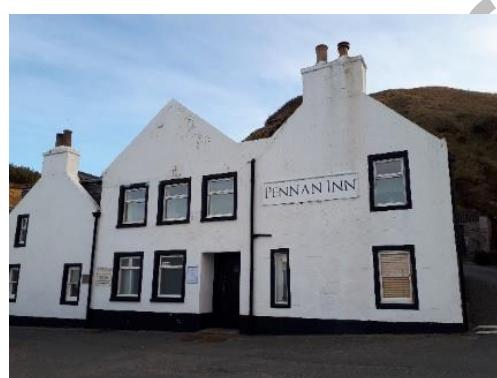
The vast majority of dwellings in Pennan are in a good condition and are well cared for, however due to the setting, maintenance is a constant consideration on these buildings and materials can look aged and deteriorate more quickly than they would

in a different location. Some properties are showing areas of staining which appears to be caused by rusting on elements on the building. This may be from old fixtures to the buildings from when the cabling was above ground.

Some properties have not been as recently painted as others along the shoreline, and therefore are looking tired in comparison. Due to the cement coating on these buildings, when there is a failure to these, it can be noticeable, and if not fixed can cause the coating to further fail. At times of frost, water can get in behind and expand, causing the cement to come away, exposing the stonework below which is likely to be damp underneath.

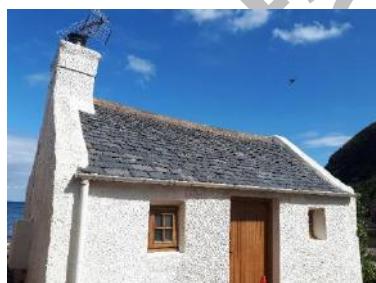
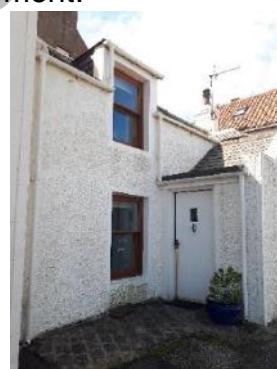
Throughout Pennan, there is a large number of uPVC rainwater goods noted on both residential and non-residential buildings. This is not suitable for conservation areas (or indeed listed buildings) and are better replaced with cast iron alternatives in keeping with the character of the historic settlement.

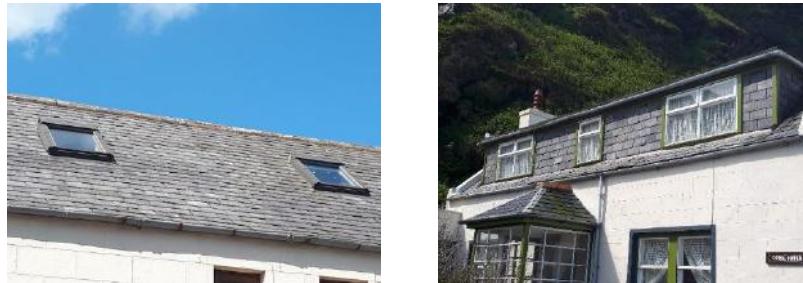
Pennan benefits from the vast majority of properties having timber windows, albeit in a variety of designs and colours. There are a small handful of uPVC windows in Pennan which are not in keeping with the character of the area. The conversion of roof spaces to living accommodation has led to the introduction of a variety of dormers and rooflights to properties. Oversized box dormers and large roof lights are inappropriate within a conservation area therefore, smaller and well-proportioned dormers and conservation rooflights would be more appropriate.
